HYDRAULIC MODEL STUDY TO REDUCE  
THE VIBRATION OF KEECHELUS DAM  
OUTLET WORKS--YAKIMA PROJECT,  
WASHINGTON

Hydraulic Laboratory Report No. Hyd-342

Subject: Hydraulic model study of the vibration of Keechelus Dam  
Outlet Works--Yakima Project, Washington

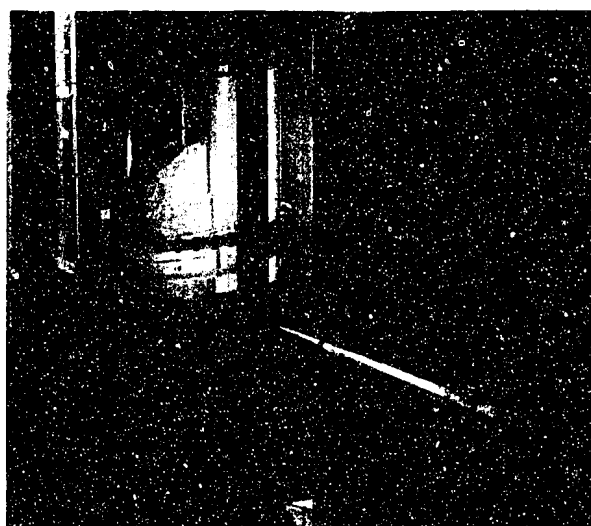
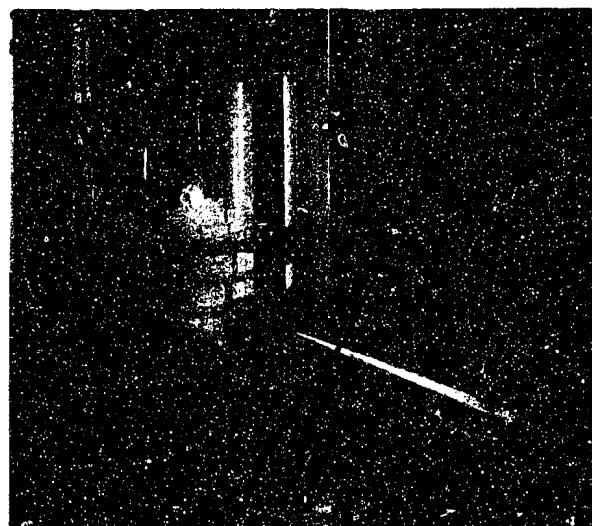
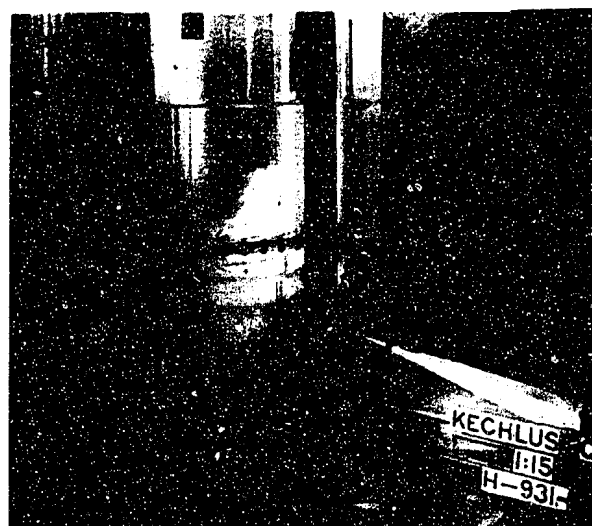
Figure 6  
Report Hyd 342

VIBRATION STUDIES - KEECHELUS OUTLET WORKS  
Flow disturbance in model gate tower--Discharge 1800 cfs  
Reservoir Elevation 2467.5--Lower ring gate 50 percent open

The model was first operated at various reservoir elevations, discharges, and combinations of openings for the two cylinder gate controls. This was done to observe flow conditions which might be conducive to the forces which caused the prototype structure to vibrate. Rapid, violent, and irregular flow disturbances in the form of surges occurred within the inner cylinder. These surges were recorded on photographs, using an electronic flashlamp and camera. This method was used because illumination by flashlamp penetrated and defined the surge better than ordinary floodlighting. Typical surges were recorded at 50 percent cylinder gate opening for a discharge of 1,800 cfs and reservoir elevation 2467.5, and a discharge of 2,720 cfs and reservoir elevation 2520 (Figures 6 and 7).

Water flowed through the nine passages at the lower cylinder gate to the inner cylinder and formed large random eddies and surges. In general, the water flowed across the inner cylinder toward the exit conduit. Periodically, an unstable roller formed and rotated in a vertical plane back toward the upstream side within the inner cylinder. The instability of the roller and eddies affected the flow into the conduit entrance causing a fluctuation of the discharge. During the period that the outflow from the inner cylinder was retarded, the inflow under nearly constant head from the outer cylinder and reservoir was stored and increased the inner cylinder depth. With the increased depth in the cylinder, more of the inflow energy was absorbed, the eddies subsided, and the discharge again increased. This surging explained the statement " \* \* \* rather explosive blasts of entrapped air which blow upward through the gatehouse with violent force" contained in the previously cited letter. The upward surging water which acted as a large piston compressed the air within the inner cylinder and forced it rapidly through the gatehouse. Although not specifically mentioned in the letter, a reversal of this process should occur with less noticeable force as the surge recedes and creates a low pressure within the tower. From observations and testing, the surges and the quantity of water concerned were sufficiently large to produce pressure forces which caused a vibration of the gate tower. If the surges had not been so rapid and the water surface within the tower not so turbulent, the forces acting on the tower would have been more equally distributed, and the vibration less noticeable. However, with the extremely turbulent conditions, the tower was subjected to unequal pressure distribution and rapidly changing dynamic forces.

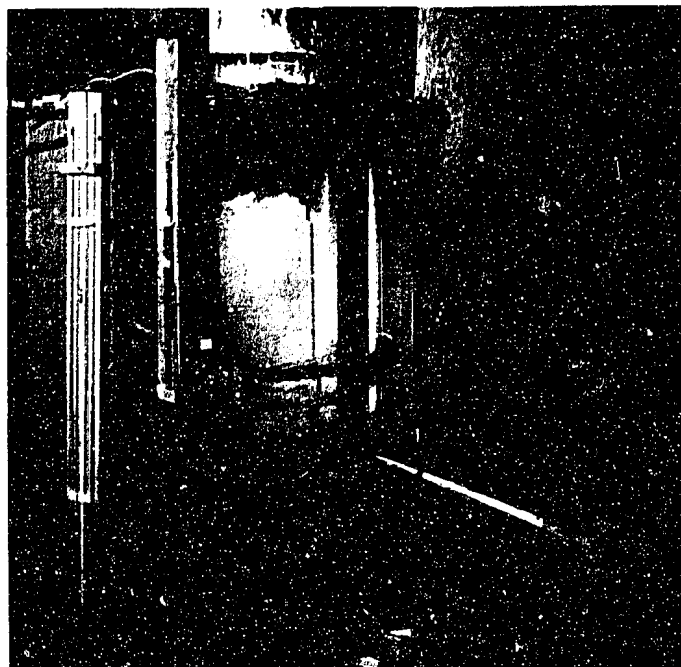
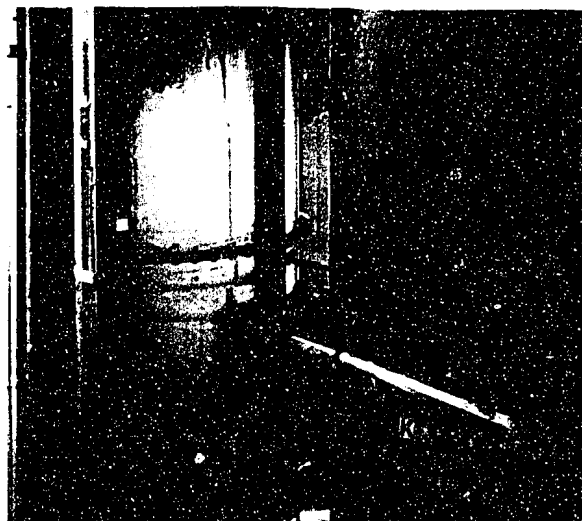
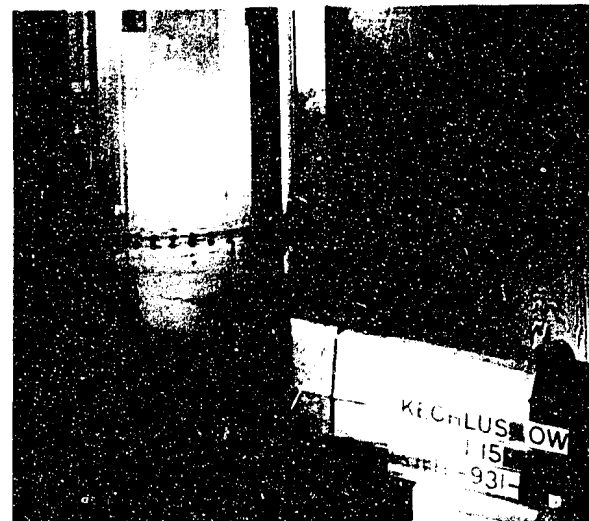
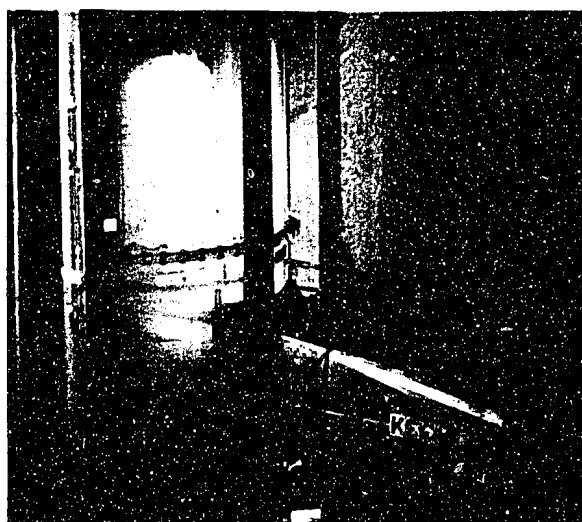
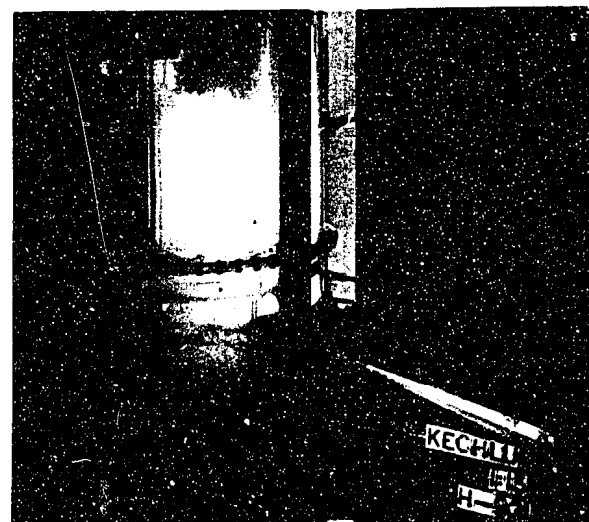
Figure 7  
Report Hyd 342

VIBRATION STUDIES - KEECHELUS OUTLET WORKS  
Flow disturbance in model gate tower--Discharge 2720 cfs  
Reservoir Elevation 2520--Lower ring gate 50 percent open
